COMPLIANCE EVALUATION INSPECTION REPORT

Solutia, Inc. WG Krummrich Plant

August 23, 2006

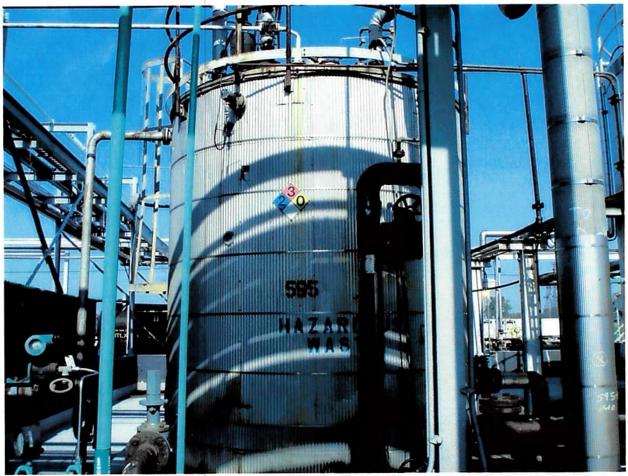
After this interview, Messrs. Fulbright, Ziesse, Ehlen and I went to the location of the hazardous waste storage tank. The tank is featured in photograph 1. The tank was labeled with the words, "Hazardous Waste," an identification number, and a National Fire Protection Association diamond. No other description of the contents was labeled or otherwise marked on the storage tank.

Secondary containment was provided for the storage tank. I did not observe the presence of any spills within, or damage to the secondary containment. A pump was located outside of the secondary containment for the storage tank, and appeared to be provided with its own containment for spills (concrete pad and curbing). According to the Solutia representatives, the pump is provided with dual mechanical seals and a barrier fluid system.

Photograph 1: Hazardous waste storage tank at the Rubber Intermediate Manufacturing Plant at Solutia Inc., W.G. Krummrich Plant, Sauget, IL. The tank is used to store an MIBK/MEK containing organic hazardous waste stream. The digital photograph was taken on August 23, 2006, at approximately 9:40 A.M. The photographer was Todd Brown, U.S. EPA. The file name is P8230001.

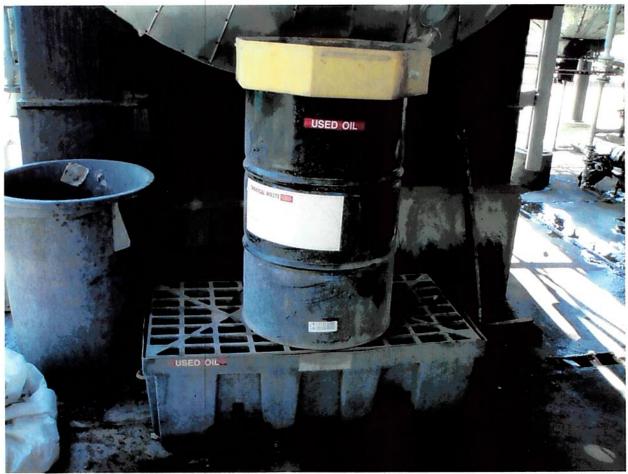
After this review, we continued with the site tour of the Rubber Plant. At this time, I observed one 55-gallon container labeled with the words, "Used Oil" (photograph 2). In addition, I observed several 55-gallon containers of spent platinum catalyst. The containers had accumulation dates ranging from April through May, 2006. According to Mr. Fulbright, this material would be recycled. I noted that fire extinguishers, emergency showers, and fire hydrants were present.

Photograph 2: Container of Used Oil at the Rubber Intermediate Manufacturing Plant at Solutia Inc., W.G. Krummrich Plant, Sauget, IL. The digital photograph was taken on August 23, 2006, at approximately 10:15 A.M. The photographer was Todd Brown, U.S. EPA. The file name is P8230002.

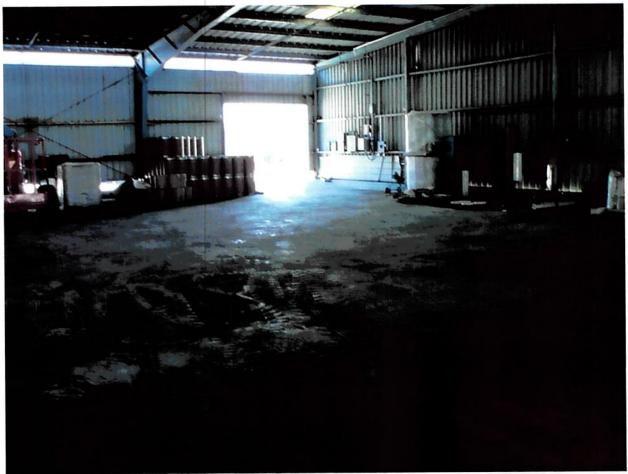
At the entrance of the BBU Building, I noted that two emergency showers were present. The inside of the BBU building is separated into two halves, for the storage of hazardous waste and non-hazardous waste respectively. At the time of my inspection, no hazardous waste appeared to be present at the side of the building used for its storage. Only empty containers and various pieces of equipment were present in the area (photograph 3).

Photograph 3: Inside of the BBU building at Solutia Inc., W.G. Krummrich Plant, Sauget, IL. The photograph features the side of the building used to store hazardous waste generated by Solutia. The digital photograph was taken on August 23, 2006, at approximately 10:32 A.M. The photographer was Todd Brown, U.S. EPA. The file name is P8230003.

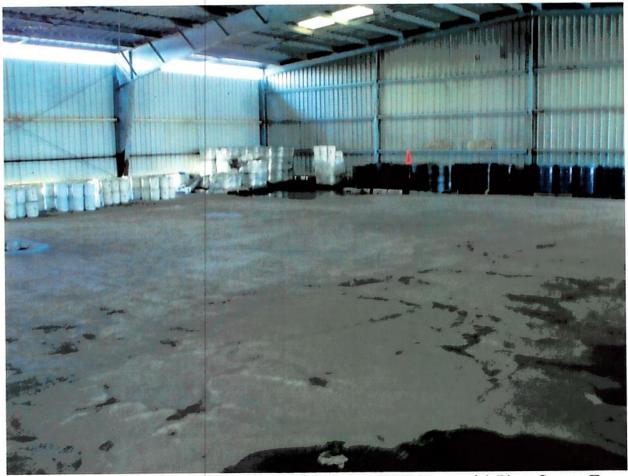
At the side of the building used to store non-hazardous waste, I noted that 22 55-gallon containers labeled "Chemical Plant Waste" were present. According to Mr. Fulbright, the waste was not hazardous waste. The containers were marked with accumulation dates that ranged from March through June, 2006.

Photograph 4: Inside of the BBU building at Solutia Inc., W.G. Krummrich Plant, Sauget, IL. The photograph features the side of the building used to store non-hazardous waste generated by Solutia. The 5-gallon pails and 55-gallon containers featured in the photograph reportedly contained investigatory soil samples. The digital photograph was taken on August 23, 2006, at approximately 10:39 A.M. The photographer was Todd Brown, U.S. EPA. The file name is P8230004.
